Please find attached, Investigation Report for the vehicle (New Norfolk 5.1) rollover at [REDACTED] which occurred on 31 January 2019.

INVESTIGATION REPORT**Crash Investigation
New Norfolk 5:1 Roll Over
[REDACTED] Geeveston****31 January 2019****Persons Involved:-**

Investigation conducted by:-**SSO Peter Tavaszi 4 February 2019**

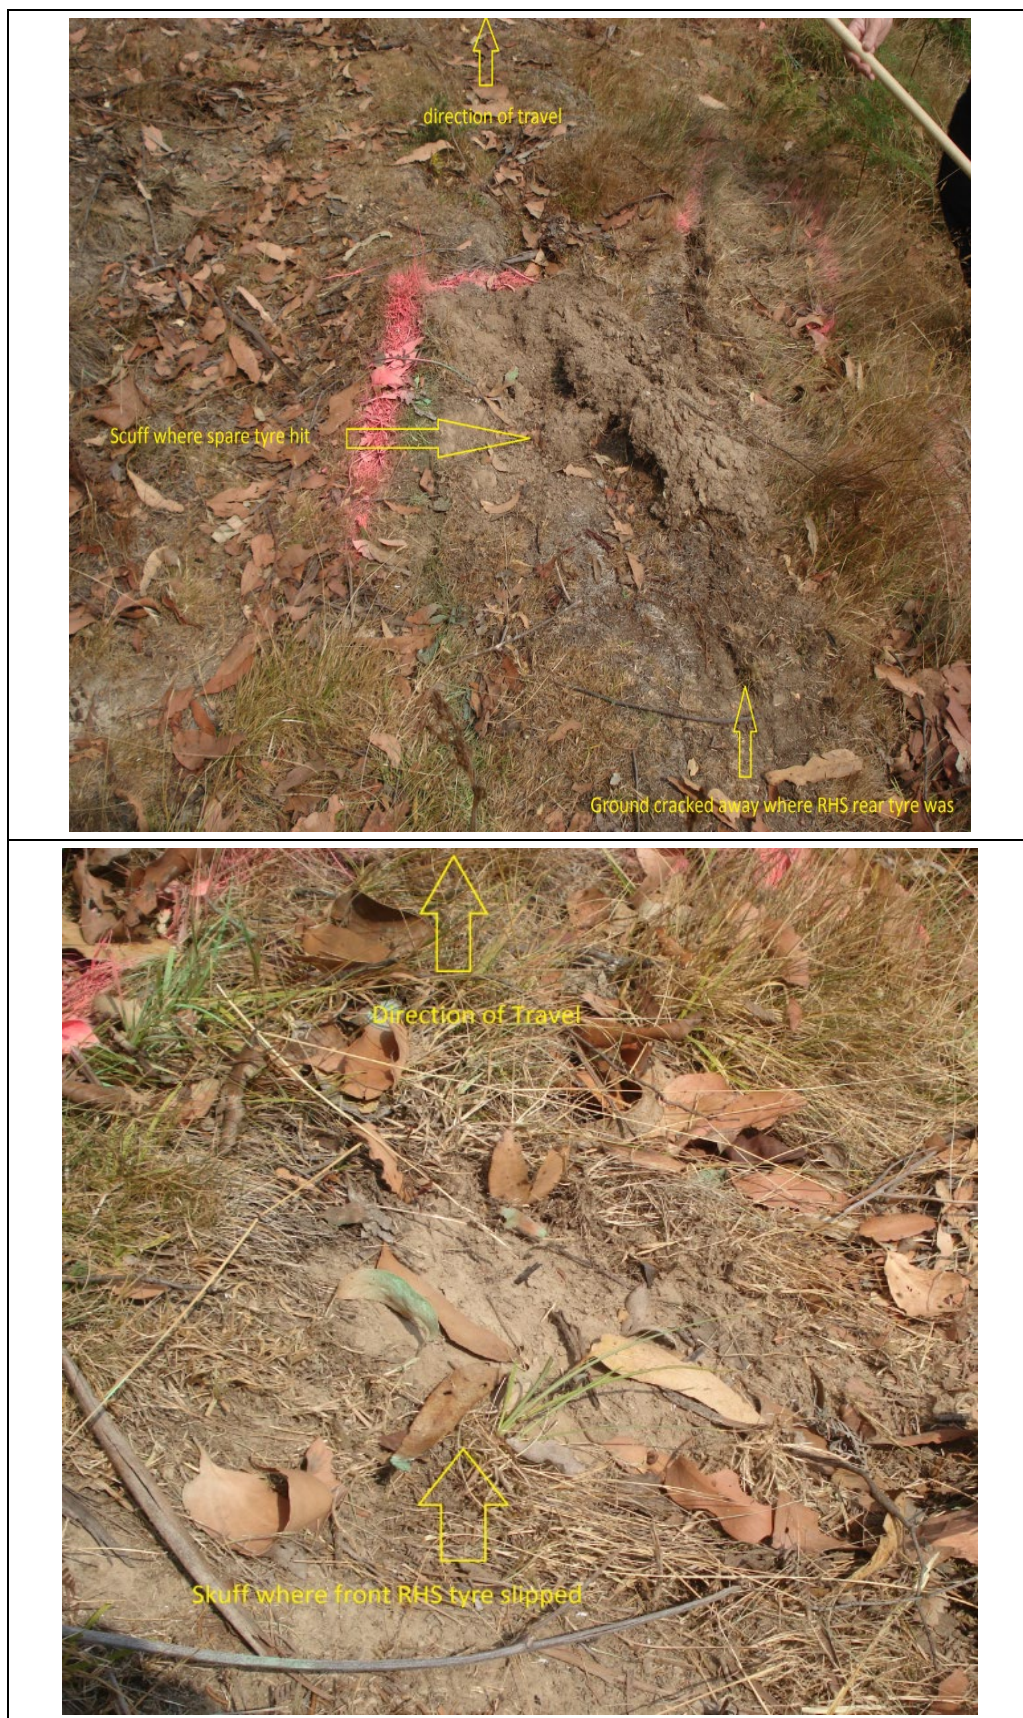
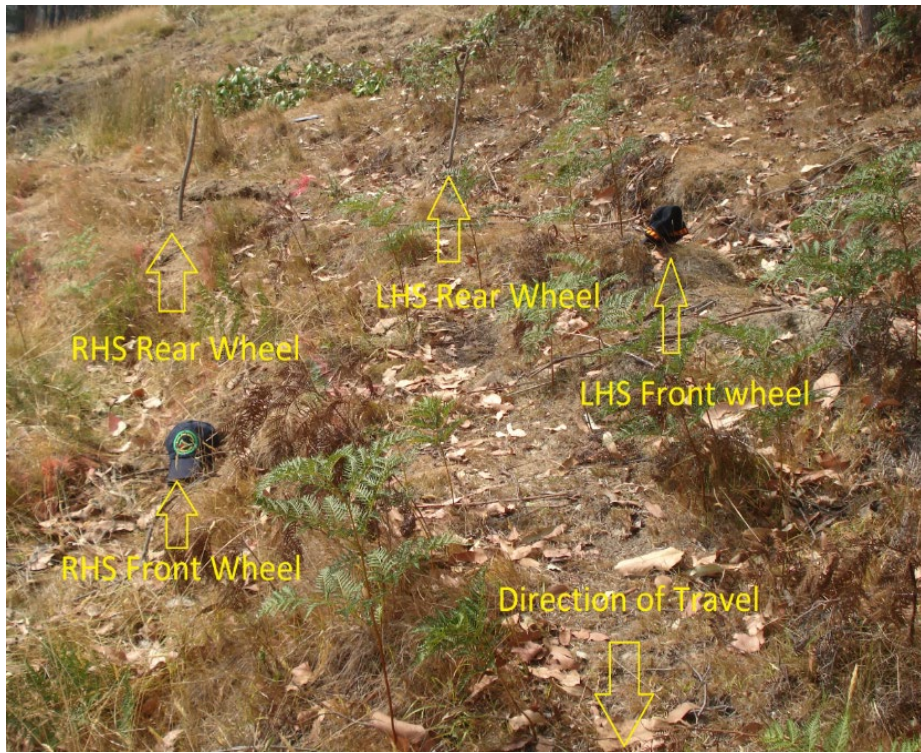
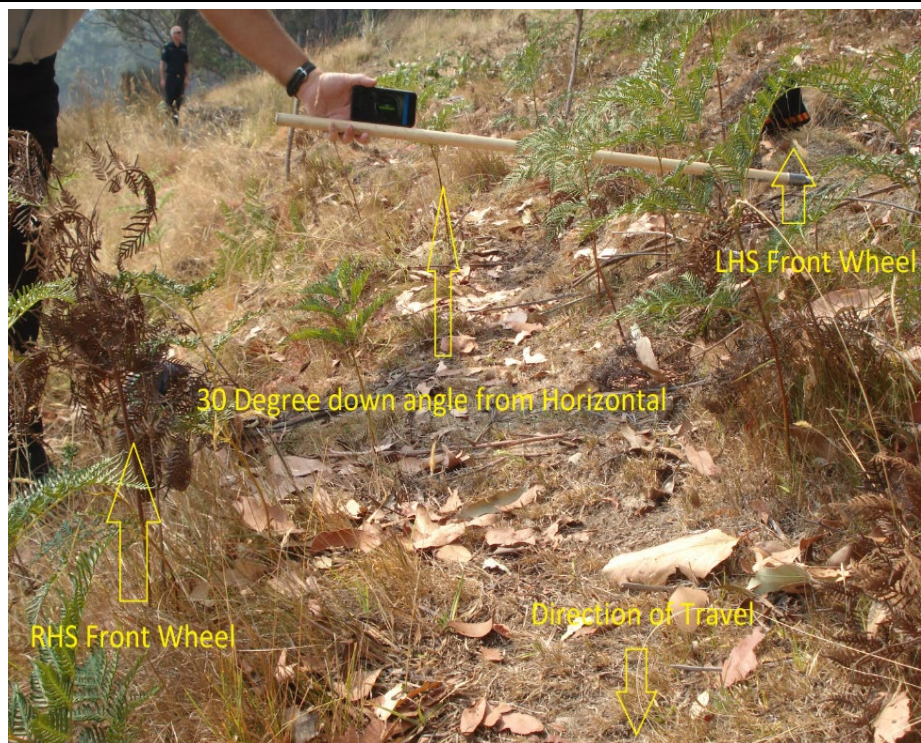
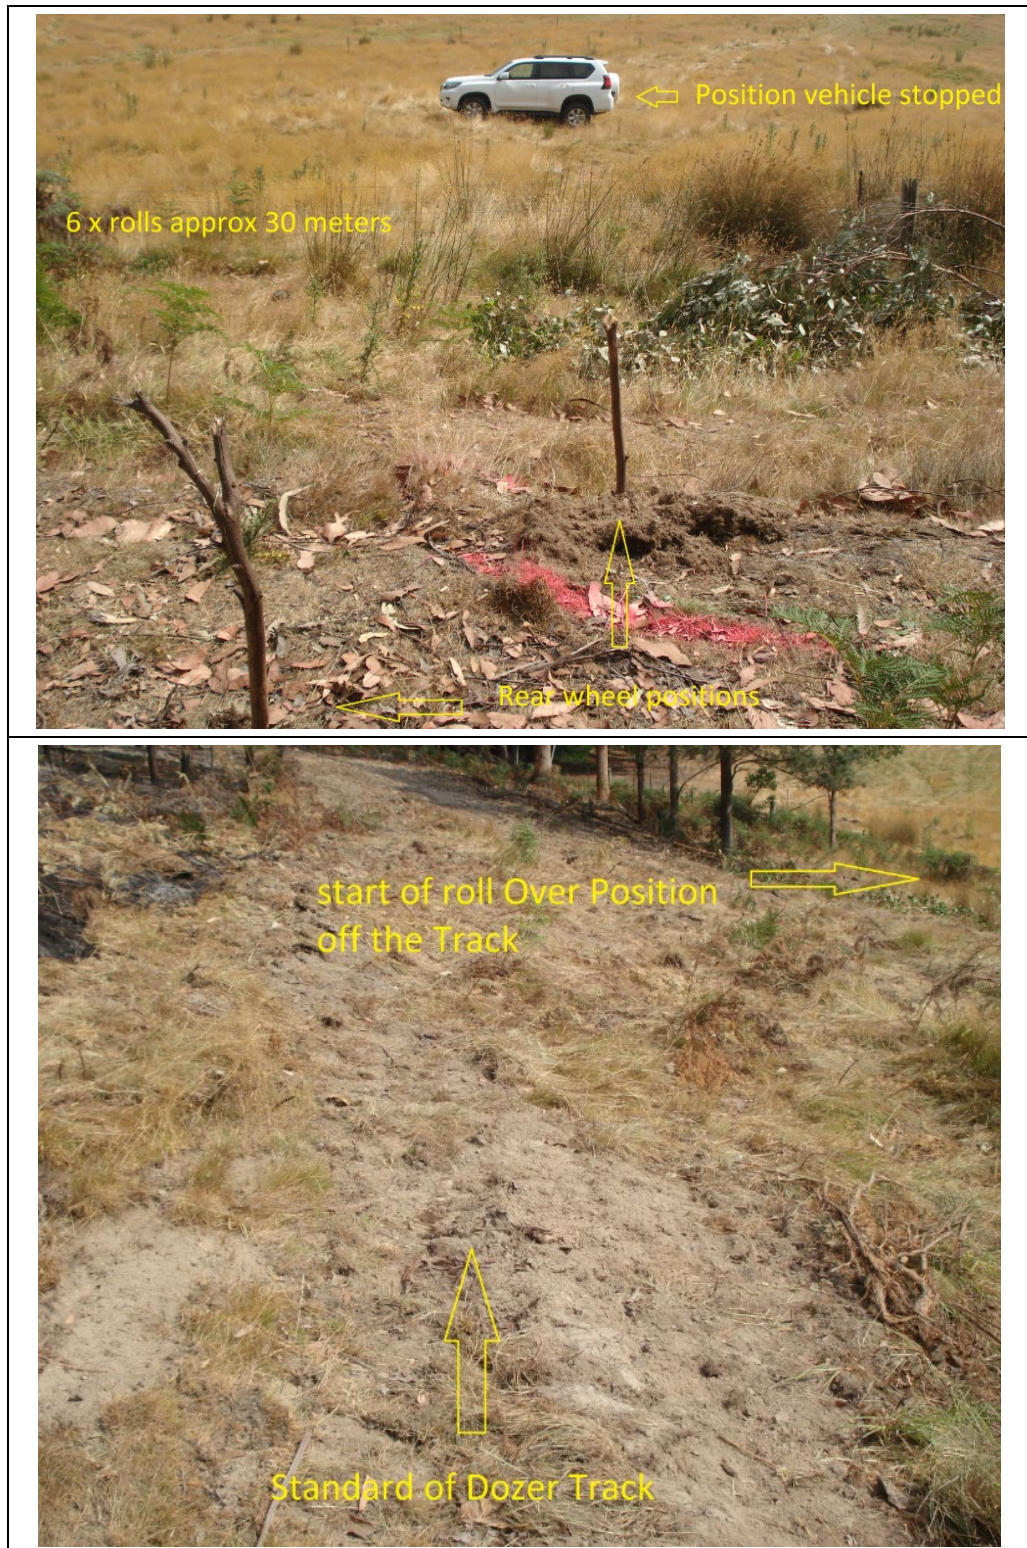
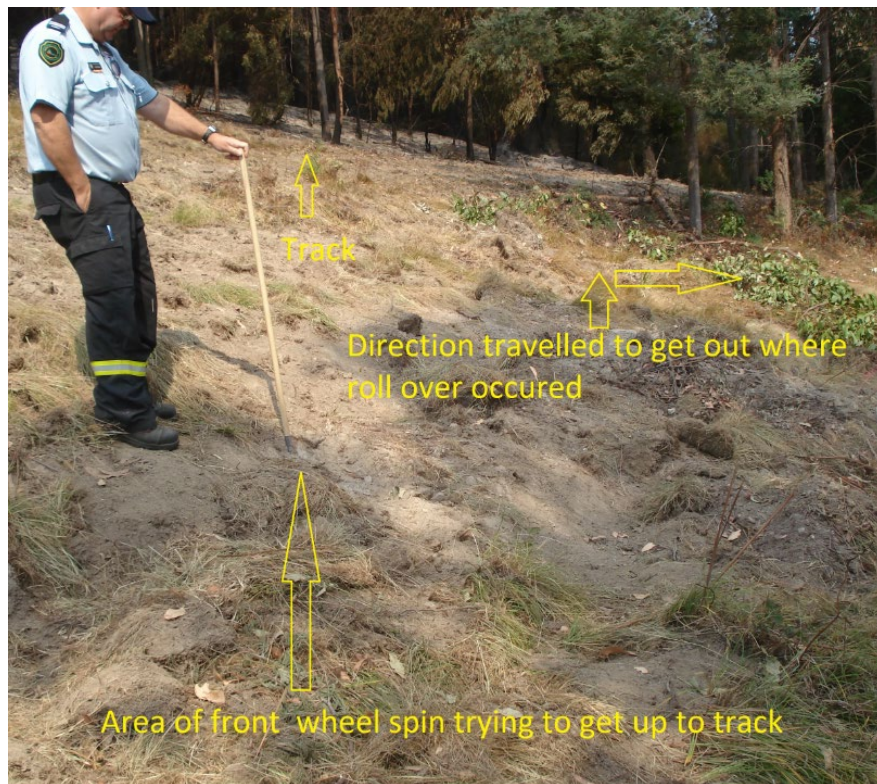
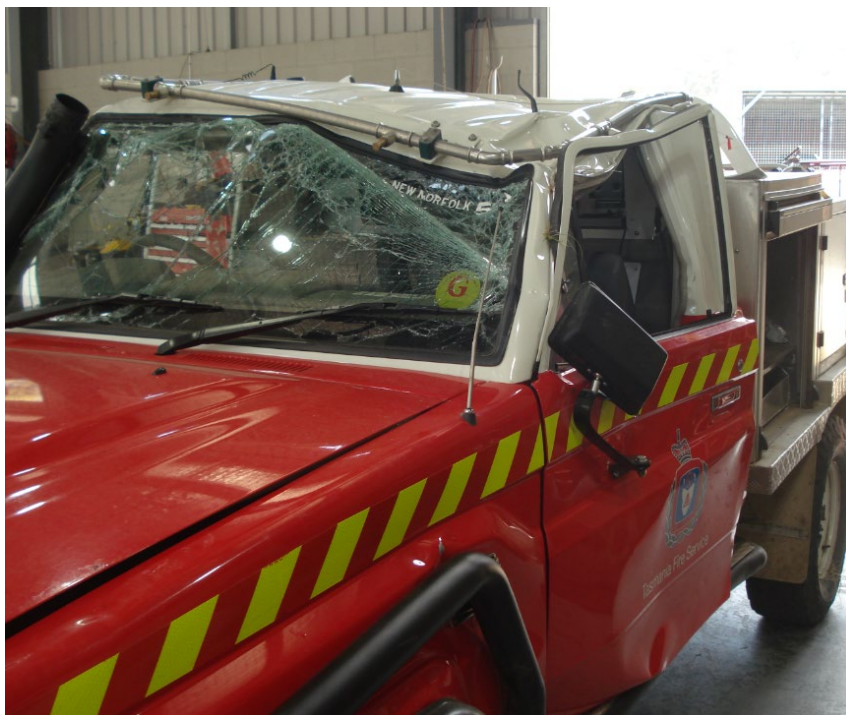
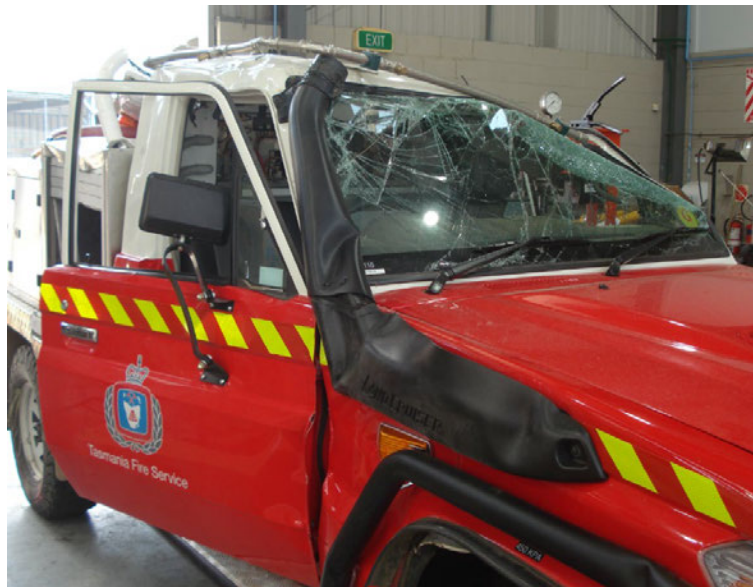
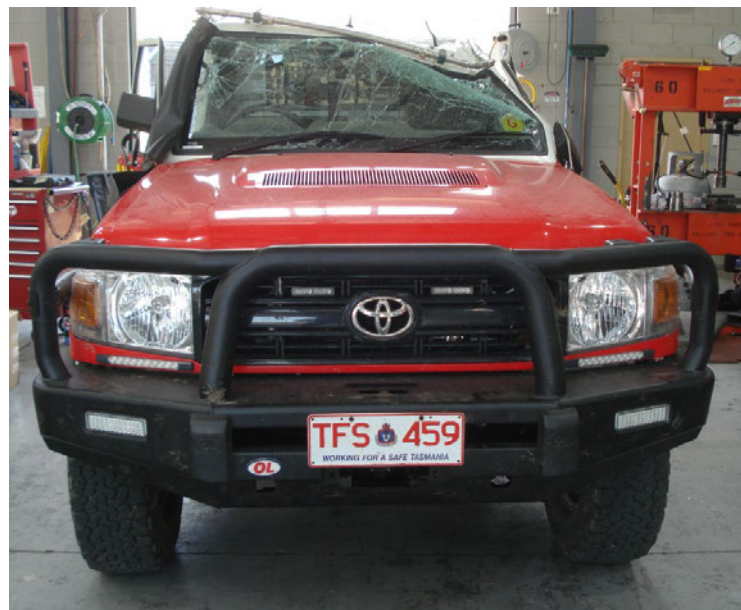
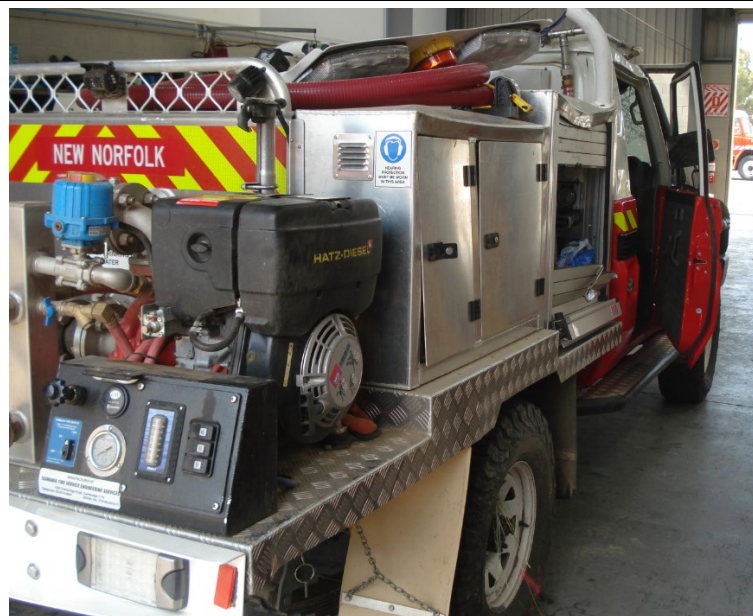
Incident Scene Photographs:-

An onsite inspection was completed at 12:00 hours 4 February 2019. The information received from the witness's confirmed findings at the scene. All the tyre tracks, slip marks, the description of the track construction and direction of travel were correct.

- **Terrain:** Side of a North Easterly facing hill, bottom side of tree line.
- **Slope:** Slope area where roll over occurred was measured at 30 degrees using an Inclinator. There were numerous lower points, slip off areas which would have increased the angle.
- **Soil:** Vehicle had moved from soft sandy soil where the dozer was working to a hard surface where the roll occurred.
- **Grass height:** Low.

The Dozer was working across a steep slope with the wrong type of blade and track construction and with limited instruction. The New Norfolk crew followed the dozer along the track as directed. They followed the Dozer and started to realise how dangerous their position was. They stopped to ask advice about the dangers and an alternative route to get themselves out danger. Unfortunately they took advice from the Dozer Operator who thought he could see a safe route for them to exit the area.

The New Norfolk crew took his advice and viewed the area from the vehicle without getting out and checking. They proceeded forward when the vehicles wheels slipped down a small unseen low point. As the vehicle was already at angle of approximately 30 degrees the sudden slip to the right would have caused the water in the tank to slosh sideways pushing the vehicle outside of its centre of gravity consequently rolling the vehicle.

Action	Assigned to	Due date
Clearer directions to dozer operators regarding the construction of tracks to enable TFS vehicles to traverse them safely, cutting into the high side and levelling out the track.	Develop and deliver a Plant Managers and Line Locators course - Operational Training Assistant Director.	September 2019
Selection of dozers need to be considered, correct type of blade for safe TFS (all firefighting agency's) vehicle travel.	Multi Agency Coordination Group. Review Contractor/Plant register held by STT to determine plant suitability and minimum standards. Position to be communicated at the Multi Agency pre-season brief Launceston.	September 2019
All Dozers should have an accompanying experienced line locator determining a safe route.	Identify current skilled personnel to determine adequate capability. Develop and deliver a Plant Managers and Line Locators course - Operational Training Assistant Director.	September 2019

Clearer briefings and directions to crews need to be carried out highlighting all dangers and not to put themselves in a dangerous position, if not sure ask questions.	Southern Region IMT - Included in incident action plans and local briefing of crews. Regional Officers South, North and North West to include information at District briefings.	Commenced and ongoing Include information for safe off road driving at all District Briefings
Remind crews of SOLTAD i.e. you get a different prospective of the terrain out of the vehicle than inside. (Dangers would have been spotted).	Southern Region IMT - Included in incident action plans and local briefing of crews.	Commenced and ongoing
Remind crews of the dangers travelling across steep slopes with full and half full tanks of water. This lowers the centre of gravity however increases water slosh which will contribute to a roll over. If there is no immediate fire danger, emptying the water tank to exit a danger area could be an option.	Southern Region IMT - Included in incident action plans and local briefing of crews.	Commenced and ongoing
