Royal Hobart Hospital Redevelopment Project

Asbestos Contamination Assessment Royal Hobart Hospital, F Block Hobart, Tasmania

Capital Insight Pty Ltd

August 2016

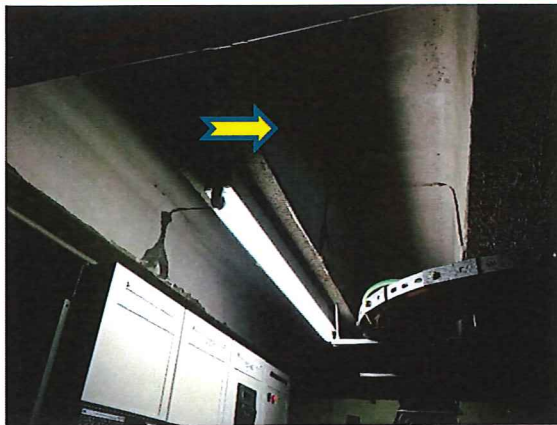
Photo 1. Exposed and unsealed asbestos cement lined coffer on lower basement level (main switch room). These are typical of coffer throughout all levels, however most are concealed above false ceilings or are encapsulated.

- Budget for the complete removal and/or effective encapsulation or enclosure of the asbestos cement coffers in the medium to longer term, to eliminate or otherwise minimise the risk of further deterioration of asbestos material and migration of contamination into occupied work spaces.

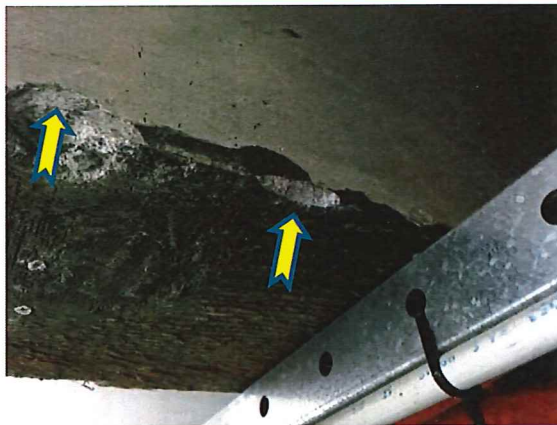
Photo 3. Exposed and unsealed asbestos cement lined coffer on lower basement level (main switch room). Evidence of previous disturbances. This is an example of damage / deterioration to the edge of the asbestos cement.

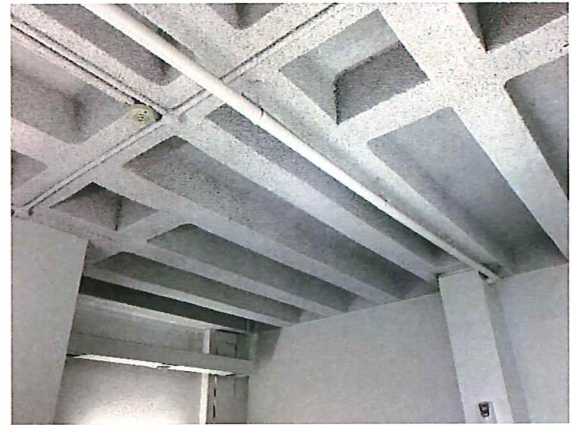
Photo 4. Example of exposed concrete slab in F Block (no false ceiling installed however the coffer are effectively encapsulated with decorative vermiculite spray or paint).

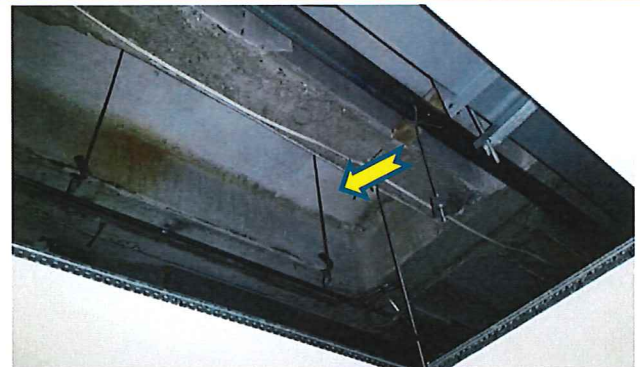
Photo 6. Example of suspended ceiling tile system with tile missing, exposing the coffer in the void above.

- Seal up the various apertures in the false ceilings across all levels as soon as practicable to minimise the potential for further migration of contamination from the ceiling voids. This should entail reinstatement of missing and dislodged ceiling tiles, and installation of temporary sheeting or other suitable building material where gaps exist, to fully seal off the ceiling void from the occupied space below. Exposed and un-encapsulated asbestos cement lined coffers (if identified above occupied work spaces - although based on Prensa's observations this scenario appears unlikely to be encountered), should be sealed with a suitable thick-build and tinted paint or similar sealant product. This is considered a lower priority in unoccupied areas such as plant rooms;

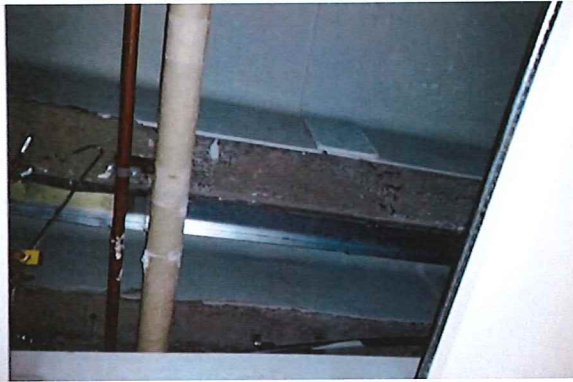
Photo 7. Example of suspended ceiling tile system with tile missing, exposing the coffer in the void above. Asbestos cement lining to coffer noted to be painted in this location.

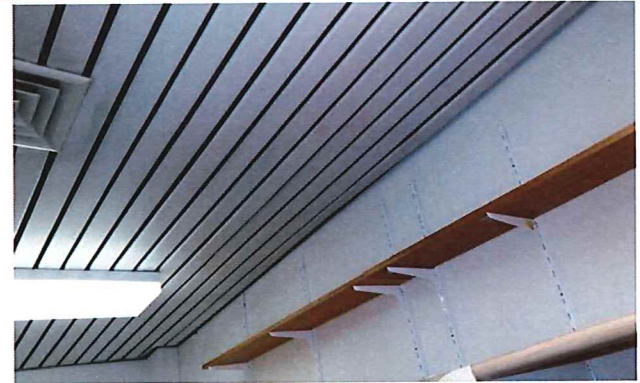
Photo 10. Aluminium slat style ceiling system with gaps between each slat (however SMF type insulation was noted installed across such gaps providing some level of protection between the void and occupied space).

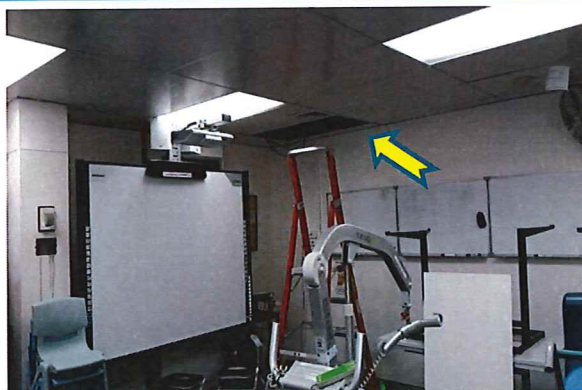
Photo 11. Example of suspended ceiling tile system with a single tile missing, exposing the coffer in the void above.

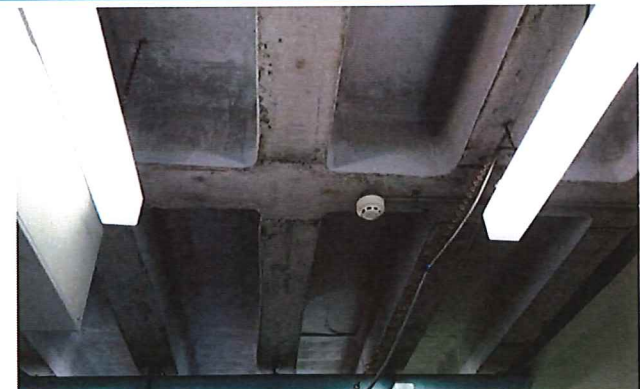
Photo 12. Example of asbestos cement lined coffers. Where no suspended ceiling is installed in occupied work spaces the coffers were generally found to be encapsulated.
